# LIFE PAINT

## WATERPROOFING

### LIFE DECK WALL TO DECK DETAIL

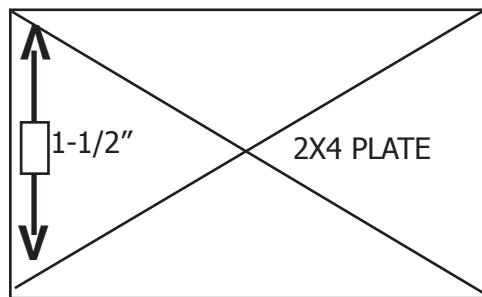
**DRAWING NOT TO SCALE**

The #1 cause for leaks on decks is the lack of proper flashing, followed by lack of slope, and then improperly applied deck coatings. To help illustrate the flashing problem, we have prepared the following drawings for your information. Please share this with your contractor, framer, stucco-contractor, architect or anyone else you feel could benefit for this information.

Subsurface must meet local building codes. Minimum of 5/8" exterior plywood, T & G (or all seams blocked) with 1" in 4' of slope. Concrete over plywood must be at least 1-1/2"-2" thick.
